**Flood Control Project Maintenance
Levee Inspections**

Maintenance Issue Types Only, Levee Inspection Report By Mile - Spring 2017

Reclamation District No. 1601 Twitchell

Waterway	Bank	Unit Miles	Inspection Start/End	Inspector
Unit No. 01 Threemile Slough	Left	2.43	03/15/2017 03/15/2017	Richard Willoughby

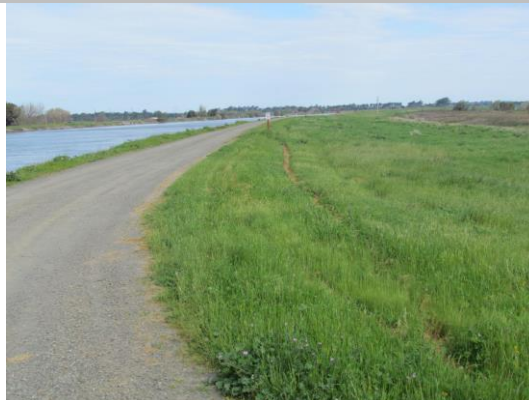
Photo 1 of 1 : SP_2017_RD1601_237_11_20170316_00020.jpg

LM Start	0.00	Rating **	M	Issue No.	11
LM End	2.42	Issue Type +	Ma	Location *	LS
Category	Earthen Levee		GPS Latitude/Longitude		
			Start	End	
Item	Vegetation		38.122258 °	38.087665 °	
			-121.682557 °	-121.683875 °	
DWR ID	DWR_RD1601_01_s_2017_11				
Comment Code					
V1 : Control annual grass and weeds on the levee slopes and easements.					
Inspector Comment

Looking northwest at typical view of landward slope.

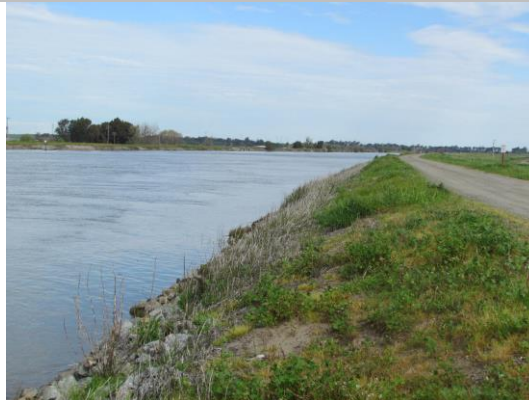
Photo 1 of 1 : SP_2017_RD1601_237_12_20170316_00019.jpg

LM Start	0.00	Rating **	M	Issue No.	12
LM End	2.42	Issue Type +	Ma	Location *	WS
Category	Earthen Levee		GPS Latitude/Longitude		
			Start	End	
Item	Vegetation		38.122258 °	38.087665 °	
			-121.682557 °	-121.683875 °	
DWR ID	DWR_RD1601_01_s_2017_12				
Comment Code					
V1 : Control annual grass and weeds on the levee slopes and easements.					
Inspector Comment

Looking northwest at typical view of waterward slope.

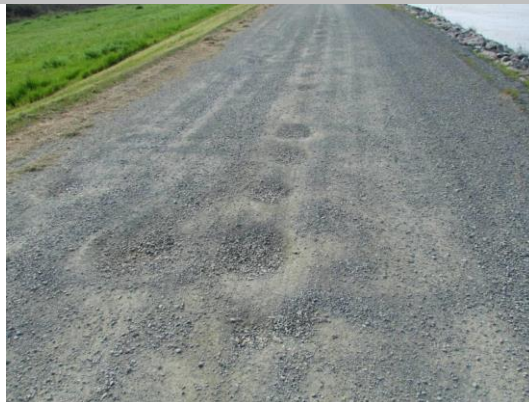
Photo 1 of 2 : SP_2017_RD1601_237_13_20170316_00021.jpg

LM Start	0.18	Rating **	M	Issue No.	13
LM End	2.42	Issue Type +	Ma	Location *	CR
Category	Earthen Levee			GPS Latitude/Longitude	
				Start	End
Item	Crown Surface / Depressions / Rutting			38.119757 °	38.087665 °
				-121.682892 °	-121.683875 °
DWR ID	DWR_RD1601_01_s_2017_13				
Comment Code					
C2 : Repair depressions or ruts in the crown or slope.					
Inspector Comment					
Control ruts and regrade levee crown.

Looking south at typical view of ruts on levee crown.

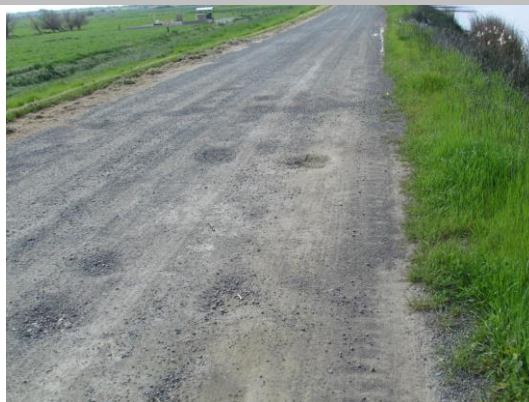
Photo 2 of 2 : SP_2017_RD1601_237_13_20170316_00022.jpg

LM Start	0.18	Rating **	M	Issue No.	13 (cont)
LM End	2.42	Issue Type +	Ma	Location *	CR
